**Flood Control Project Maintenance  
Levee Inspections**

**Spring 2016 Levee Inspection Results**

**Madera County FCWCA**

Waterway			Bank	Unit Miles
Unit No. 01 Ash Slough			Right	2.37
	Spring (March - May)	Summer (June - August)	(September - November) Fall	Winter (December - February)
Unit Maintenance Rating (Fall Only)				
Date of Inspection	4/14/2016 - 4/14/2016			
DWR Inspector	Herman Phillips			
Accompanied By	Dario Dominguez Madera Co. Public Works Dept.

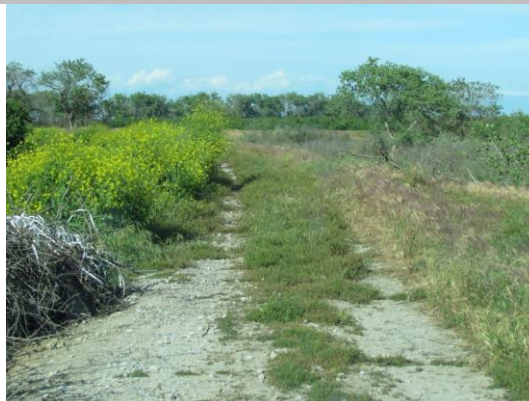
Photo 1 of 1 : SP\_2016\_NA0011\_142\_21\_20160426\_00023.jpg

LM Start	0.59	Rating **	U	Issue No.	21
LM End	2.35	Issue Type +	Ma	Location *	CR
Category	Earthen Levee			GPS Latitude/Longitude	
				Start	End
Item	Vegetation			37.050968 °	37.068513 °
				-120.419167 °	-120.398665 °
DWR ID	DWR_NA0011_01_s_2016_21				
Comment Code					
V9 : Keep the crown roadway free of vegetation.					
Inspector Comment					
Keep the crown free of vegetation.

Looking upstream from the levee mile 0.59 to 2.35 tall weeds growing on the crown roadway.

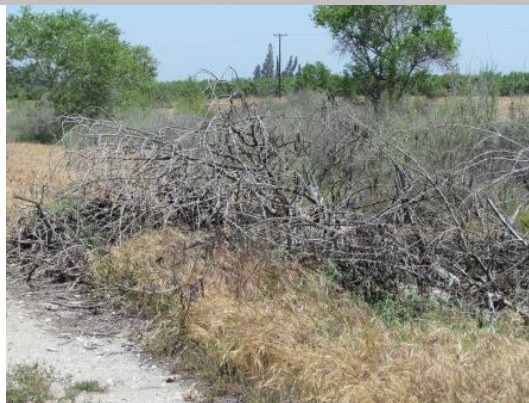
Photo 1 of 1 : SP\_2016\_NA0011\_142\_16\_20160223\_00001.jpg

LM Start	0.70	Rating **	U	Issue No.	16
LM End	0.70	Issue Type +	Ma	Location *	CR
Category	Earthen Levee			GPS Latitude/Longitude	
				Start	End
Item	Encroachments			37.052175 °	37.052175 °
				-120.417998 °	-120.417998 °
DWR ID	DWR_NA0011_01_s _ 2013_16				
Comment Code					
TR : Tree or limb					
Inspector Comment					
This tree was blown down by high winds, District needs to completely remove from levee section. Issue not corrected.

This dead tree has not been removed from the levee section, the shoulder, slope and toe is blocked. Photo taken 4-29-2014. There is no new picture for this issue. No change has been made prior to Fall inspection 2014.

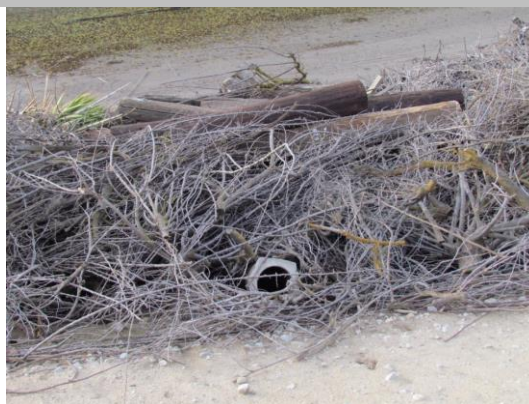
Photo 1 of 1 : SP\_2016\_NA0011\_142\_28\_20160223\_00007.jpg

LM Start	0.72	Rating **	U	Issue No.	28
LM End	0.73	Issue Type +	Ma	Location *	LS
Category	Earthen Levee			GPS Latitude/Longitude	
				Start	End
Item	Encroachments			37.052350 °	37.052530 °
				-120.417874 °	-120.417800 °
DWR ID	DWR_NA0011_01_s _ 2014_28				
Comment Code					
PR : Prunings					
Inspector Comment					
The brush pile here is providing habitat for the rodents.

Unwanted brush pile on the landside toe and slope.

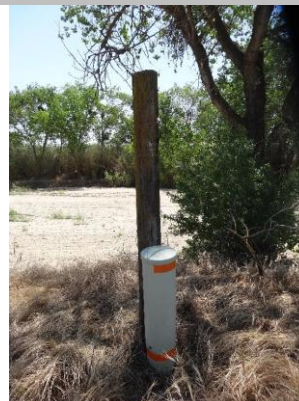
Photo 1 of 1 : UCIP\_SP\_2016\_39846\_71806.jpg

LM Start	2.09	Rating **	M	Issue No.	48
LM End	2.09	Issue Type +	En	Location *	WS
Category	Supplemental			GPS Latitude/Longitude	
				Start	End
Item	DWR UCIP Field Study			37.065569 °	37.065569 °
				-120.400752 °	-120.400752 °
DWR ID					
Comment Code					
Inspector Comment					
FS_ID:39846					
DS_ID:21511					
EP_NO: N/A					
Repair Type: Non-Urgent					
Crossing Status: Indicator Found					
UCIP Comments: Need to contact to owner to get contact information.					
FIELD_STRUCT_DESC: Underground telephone cable crosses through levee.					
FS Date: 5/6/2014

Conduit box located on waterward side.

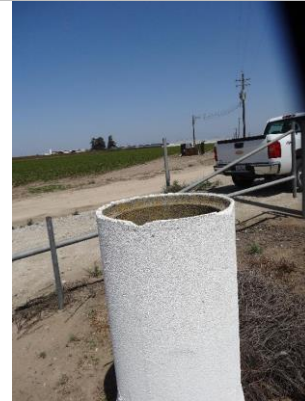
Photo 2 of 2 : UCIP\_SP\_2016\_39845\_71803.jpg

LM Start	2.10	Rating **	M	Issue No.	47 (cont)	
LM End	2.10	Issue Type +	En	Location *	WS	
Category	Supplemental			GPS Latitude/Longitude		
				Start	End	
Item	DWR UCIP Field Study			37.065649 °	37.065649 °	
				-120.400663 °	-120.400663 °	
DWR ID						
Comment Code						
Inspector Comment						
FS_ID:39845 DS_ID:25042 EP_NO: N/A Repair Type: Non-Urgent Crossing Status: Found UCIP Comments: Need to contact owner to determine if crossing goes through levee. FIELD_STRUCT_DESC: 10-inch or 12-inch pipe through levee crossing visible inside concrete standpipe on waterward side. Potential pump station located on landward side approximately 100 feet from standpipe. FS Date: 5/6/2014

Standpipe visible on waterward side.

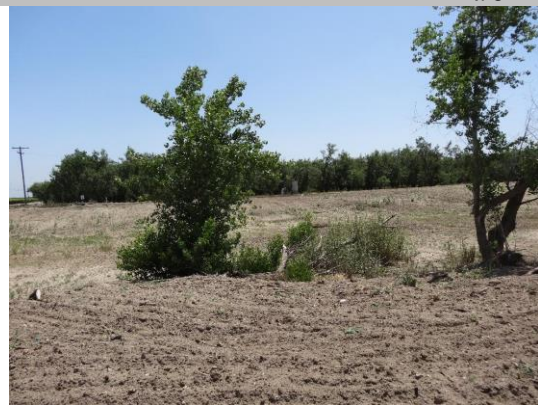
Photo 1 of 2 : UCIP\_SP\_2016\_38226\_69679.jpg

LM Start	2.37	Rating **	M	Issue No.	45
LM End	2.37	Issue Type +	En	Location *	WS
Category	Supplemental			GPS Latitude/Longitude	
				Start	End
Item	DWR UCIP Field Study			37.068763 °	37.068763 °
				-120.398523 °	-120.398523 °
DWR ID					
Comment Code					
Inspector Comment					
FS_ID:38226 DS_ID:21512 EP_NO: N/A Repair Type: Non-Urgent Crossing Status: Found UCIP Comments: Unable to determine details of crossing and whether crossing has been abandoned. Need to find owner and determine the alignment of crossing to confirm if pipe is being extended from opposite levee. FIELD_STRUCT_DESC: Abandoned service pole, pump and two 36-inch standpipes on landward side. Pump not found in 2014 inspection. Three stand pipes found on landward side. FS Date: 5/6/2014

View of waterward side.

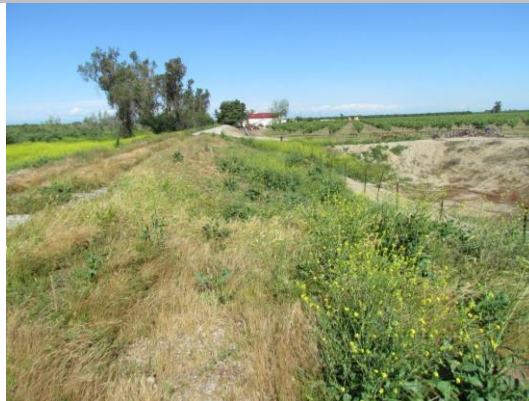
Photo 1 of 2 : SP\_2016\_NA0011\_143\_32\_20160425\_00029.jpg

LM Start	0.00	Rating **	U	Issue No.	32
LM End	0.00	Issue Type +	En	Location *	LS
Category	Earthen Levee			GPS Latitude/Longitude	
				Start	End
Item	Encroachments			37.045539 °	37.045505 °
				-120.427444 °	-120.427473 °
DWR ID	DWR_NA0011_02_f_2012_32				
Comment Code					
DT : Ditch					
Inspector Comment					
There is a settling basin on the landward side of the levee. This basin is very close to the landside easement. 4-14,-16 This basin remains, no change.

Ash slough at levee mile 0.00 there still exist this settling basin within the 10-foot of landward toe.

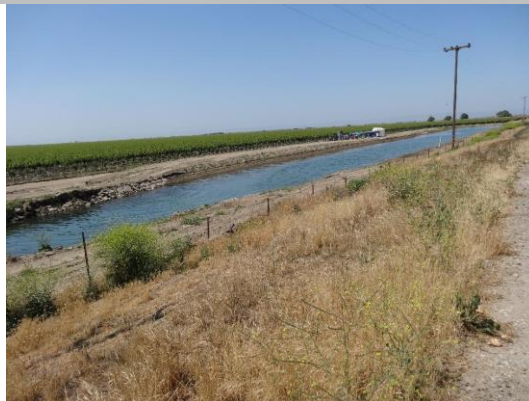
Photo 1 of 2 : UCIP\_SP\_2016\_39686\_71662.jpg

LM Start	0.01	Rating **	M	Issue No.	48
LM End	0.01	Issue Type +	En	Location *	WS
Category	Supplemental			GPS Latitude/Longitude	
				Start	End
Item	DWR UCIP Field Study			37.045532 °	37.045532 °
				-120.427268 °	-120.427268 °
DWR ID					
Comment Code					
Inspector Comment					
FS_ID:39686 DS_ID:21585 EP_NO: 8068 Repair Type: Non-Urgent Crossing Status: Found UCIP Comments: Unable to confirm if crossing found in the field corresponds to the crossing described under Permit 8068. Only 1 crossing found permit indicates 2 irrigation culverst. Need to contact owner to obtain additional details of crossing. FIELD_STRUCT_DESC: To retain two irrigation culverts and siphons located at the intersection of Ash Slough and the Chowchilla Canal. FS Date: 5/6/2014

View of landward side.

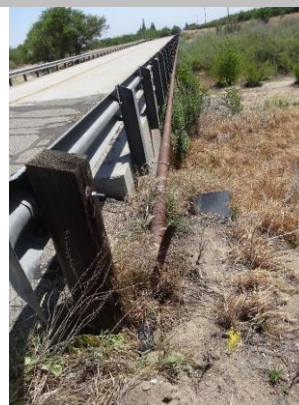
Photo 2 of 2 : UCIP\_SP\_2016\_39923\_71822.jpg

LM Start	0.94	Rating **	M	Issue No.	49
LM End	0.94	Issue Type +	En	Location *	WS
Category	Supplemental			GPS Latitude/Longitude	
				Start	End
Item	DWR UCIP Field Study			37.054547 °	37.054547 °
				-120.415826 °	-120.415826 °
DWR ID					
Comment Code					
Inspector Comment					
FS_ID:39923 DS_ID:25043 EP_NO: N/A Repair Type: Non-Urgent Crossing Status: Found UCIP Comments: Need to contact owner to determine status. Need permit authorizing work. FIELD_STRUCT_DESC: 5-inch steel conduit along bridge downstream face. Upstream face has 2-inch pipe cut at the corner. FS Date: 5/6/2014

View of steel conduit through levee and above channel.

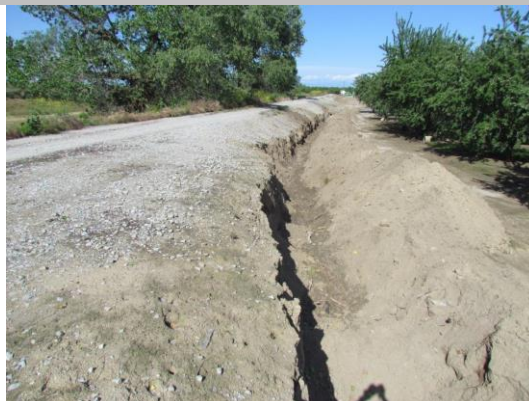
Photo 2 of 4 : SP\_2016\_NA0011\_143\_31\_20160425\_00035.jpg

LM Start	<b>1.49</b>	Rating **	U	Issue No.	<b>31 (cont)</b>
LM End	<b>1.52</b>	Issue Type +	Ma	Location *	LS

Standing at levee mile 1.49 looking towards levee mile 1.52

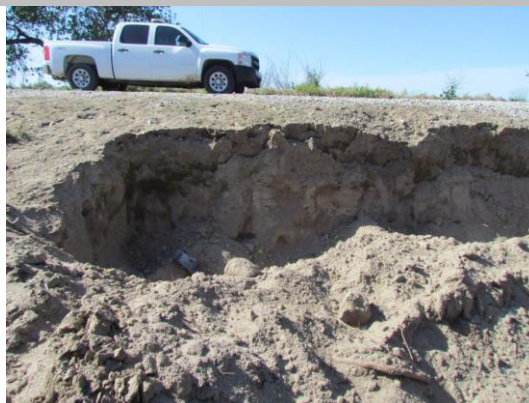
Photo 3 of 4 : SP\_2016\_NA0011\_143\_31\_20160425\_00038.jpg

Standing at the downstream end of cut landward levee toe mile 1.49.

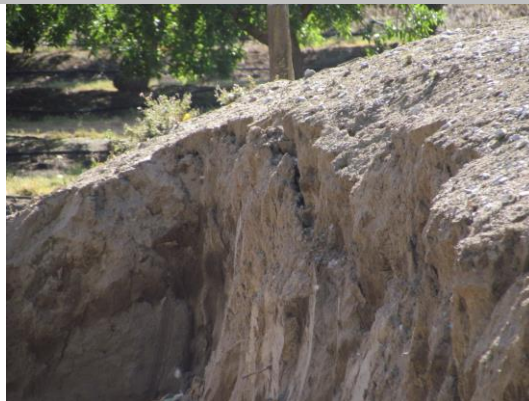
Photo 4 of 4 : SP\_2016\_NA0011\_143\_31\_20160425\_00042.jpg

LM Start	<b>1.49</b>	Rating **	U	Issue No.	<b>31 (cont)</b>
LM End	<b>1.52</b>	Issue Type +	Ma	Location *	LS

Looking downstream from the landside slope.

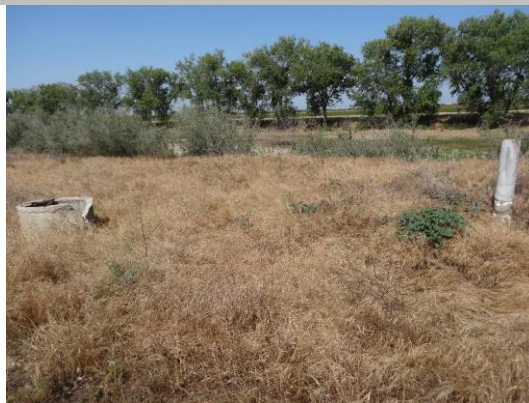
Photo 1 of 2 : UCIP\_SP\_2016\_39925\_71815.jpg

LM Start	2.02	Rating **	M	Issue No.	51
LM End	2.02	Issue Type +	En	Location *	WS
Category	Supplemental			GPS Latitude/Longitude	
				Start	End
Item	DWR UCIP Field Study			37.063982 °	37.063982 °
				-120.401165 °	-120.401165 °
DWR ID					
Comment Code					
Inspector Comment					
FS_ID:39925 DS_ID:25045 EP_NO: N/A Repair Type: Non-Urgent Crossing Status: Indicator Found UCIP Comments: Need to contact owner to determine additional information about crossing and potential appurtenances. FIELD_STRUCT_DESC: 36-inch filled with concrete. FS Date: 5/6/2014

Standpipes visible on waterward side.

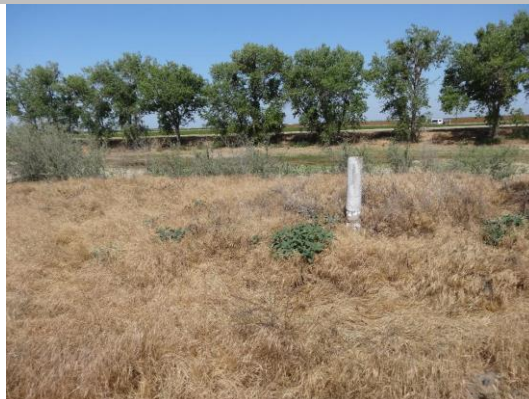
Photo 1 of 2 : UCIP\_SP\_2016\_39924\_71809.jpg

LM Start	2.03	Rating **	M	Issue No.	50	
LM End	2.03	Issue Type +	En	Location *	WS	
Category	Supplemental			GPS Latitude/Longitude		
				Start	End	
Item	DWR UCIP Field Study			37.064087°	37.064087°	
				-120.401194°	-120.401194°	
DWR ID						
Comment Code						
Inspector Comment						
FS_ID:39924						
DS_ID:25044						
EP_NO: N/A						
Repair Type: Non-Urgent						
Crossing Status: Found						
UCIP Comments: Need to contact owner to determine status.						
FIELD_STRUCT_DESC: 10-inch pipes located on waterward side.						
FS Date: 5/6/2014

Tall concrete standpipe visible on waterward side.

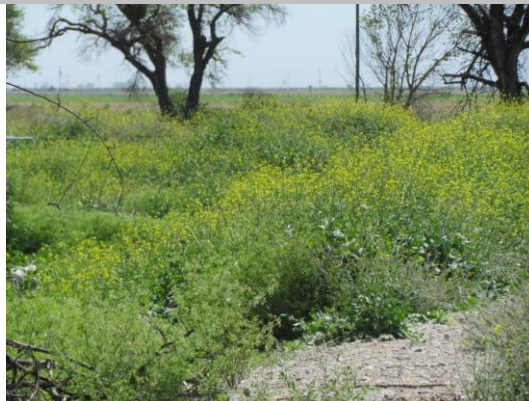
Photo 1 of 1 : SP\_2016\_NA0011\_144\_7\_20160426\_00018.jpg

LM Start	0.06	Rating **	U	Issue No.	7
LM End	1.51	Issue Type +	Ma	Location *	LS
Category	Earthen Levee			GPS Latitude/Longitude	
				Start	End
Item	Vegetation			36.996408 °	36.996618 °
				-120.372757 °	-120.346613 °
DWR ID	DWR_NA0011_03_s_2016_7				
Comment Code					
V2 : Remove the wild growth other than native grasses from the levee slopes.					
Inspector Comment					
Remove the wild mustards from the levee section landward.

Looking up stream from levee mile 0.06 - 1.51 wild mustards 4.0-foot tall.

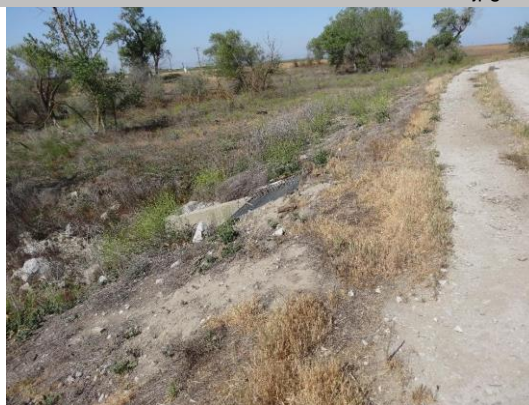
Photo 1 of 2 : UCIP\_SP\_2016\_38228\_69689.jpg

LM Start	0.10	Rating **	M	Issue No.	47
LM End	0.10	Issue Type +	En	Location *	LS
Category	Supplemental			GPS Latitude/Longitude	
				Start	End
Item	DWR UCIP Field Study			36.996177 °	36.996177 °
				-120.371967 °	-120.371967 °
DWR ID					
Comment Code					
Inspector Comment					
FS_ID:38228					
DS_ID:21517					
EP_NO: N/A					
Repair Type: Non-Urgent					
Crossing Status: Found					
UCIP Comments: Need to contact owner to determine status of crossing. Unable to determine if crossing is in use.					
FIELD_STRUCT_DESC: 36-inch CM pipe through the levee, 7.3 feet below the crown. Headwalls and wing walls on both ends. Flap gate on waterward end.					
FS Date: 5/6/2014

View of waterward side.

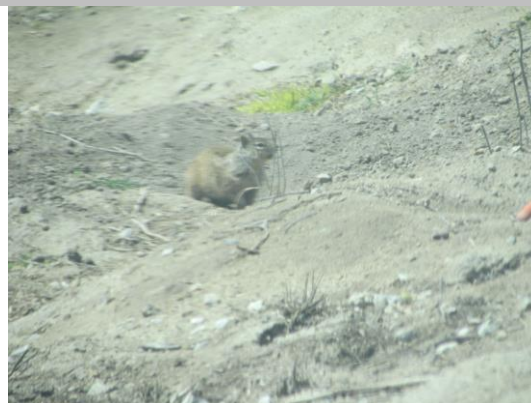
Photo 3 of 3 : SP\_2016\_NA0011\_144\_41\_20160426\_00025.jpg

LM Start	<b>0.71</b>	Rating **	U	Issue No.	<b>41 (cont)</b>
LM End	<b>1.51</b>	Issue Type +	Ma	Location *	LS

One of many active rodent captured in this photo.

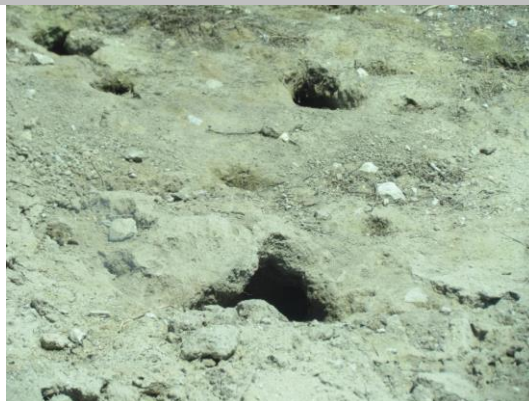
Photo 1 of 2 : SP\_2016\_NA0011\_145\_2\_20160428\_00020.jpg

LM Start	<b>0.01</b>	Rating **	U	Issue No.	<b>2 (cont)</b>
LM End	<b>0.45</b>	Issue Type +	Ma	Location *	LS

From levee miles 0.01-0.45 landside slope rodents are very active here.

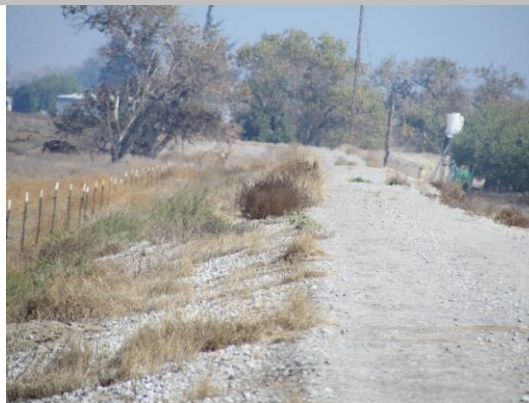
Photo 1 of 2 : SP\_2016\_NA0011\_145\_30\_20160223\_00009.jpg

LM Start	1.63	Rating **	U	Issue No.	30 (cont)
LM End	2.23	Issue Type +	Ma	Location *	WS

Berenda Slough looking upstream water side levee slope covered with rodent holes.

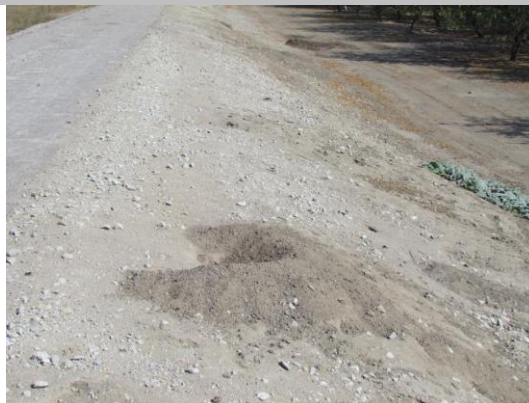
Photo 1 of 2 : SP\_2016\_NA0011\_145\_57\_20160223\_00012.jpg

LM Start	1.63	Rating **	U	Issue No.	57
LM End	2.23	Issue Type +	Ma	Location *	LS
Category	Earthen Levee			GPS Latitude/Longitude	
				Start	End
Item	Animal Control			36.996574 °	37.003328 °
				-120.344430 °	-120.337604 °
DWR ID	DWR_NA0011_04_s _ 2012_57				
Comment Code					
A1 : Exterminate rodents and backfill and compact or grout burrows.					
Inspector Comment					
The District really needs to do a better job of controlling the rodents. There should be bait stations with rodent bait present along the landside slope within the infested area.

Berenda Slough looking downstream from the landside slope at large rodent holes on the slope shoulder and crown roadway.

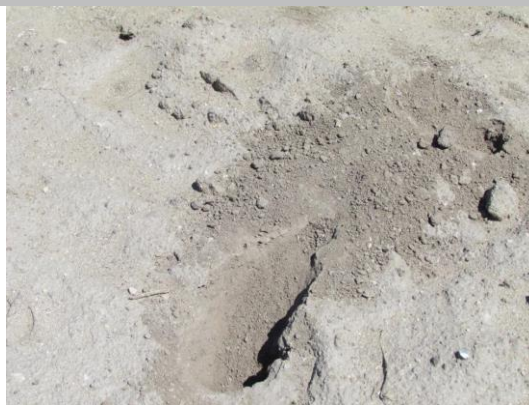
Photo 2 of 2 : SP\_2016\_NA0011\_145\_57\_20160502\_00024.jpg

LM Start	1.63	Rating **	U	Issue No.	57 (cont)
LM End	2.23	Issue Type +	Ma	Location *	LS

There are fresh rodent holes but so view of rodent.

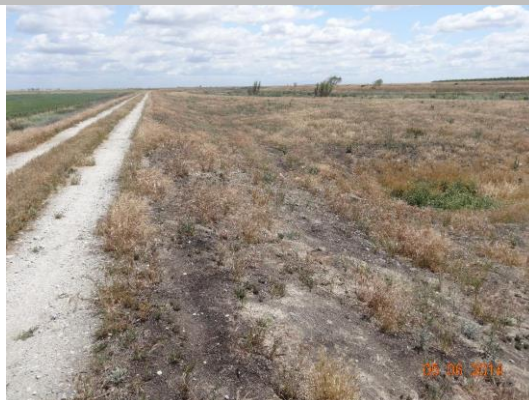
Photo 1 of 2 : UCIP\_SP\_2016\_35795\_64567.jpg

LM Start	0.18	Rating **	M	Issue No.	46
LM End	0.18	Issue Type +	En	Location *	WS
Category	Supplemental			GPS Latitude/Longitude	
				Start	End
Item	DWR UCIP Field Study			36.978036 °	36.978036 °
				-120.365246 °	-120.365246 °
DWR ID					
Comment Code					
Inspector Comment					
FS_ID:35795 DS_ID:21520 EP_NO: N/A Repair Type: Non-Urgent Crossing Status: Found UCIP Comments: Need to contact owner. Dense vegetation limits the inspector's visibility to identify signs of pipe failure (leaks) along the landward slope. Recommend removing vegetation along pipe alignment to conduct proper inspection of structure. FIELD_STRUCT_DESC: 36-inch CM pipe through the levee, 10.8 feet below the crown. Headwalls and wing walls on both ends. Flap gate on waterward end. FS Date: 5/6/2014

View of waterward side.

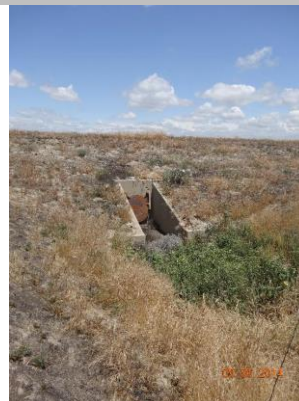
Photo 2 of 2 : UCIP\_SP\_2016\_35795\_64566.jpg

LM Start	0.18	Rating **	M	Issue No.	46 (cont)	
LM End	0.18	Issue Type +	En	Location *	WS	
Category	Supplemental			GPS Latitude/Longitude		
				Start		End
Item	DWR UCIP Field Study			36.978036 °	36.978036 °	
				-120.365246 °	-120.365246 °	
DWR ID						
Comment Code						
Inspector Comment						
FS_ID:35795 DS_ID:21520 EP_NO: N/A Repair Type: Non-Urgent Crossing Status: Found UCIP Comments: Need to contact owner. Dense vegetation limits the inspector's visibility to identify signs of pipe failure (leaks) along the landward slope. Recommend removing vegetation along pipe alignment to conduct proper inspection of structure. FIELD_STRUCT_DESC: 36-inch CM pipe through the levee, 10.8 feet below the crown. Headwalls and wing walls on both ends. Flap gate on waterward end. FS Date: 5/6/2014

View of flap gate and concrete headwall located on waterward side.

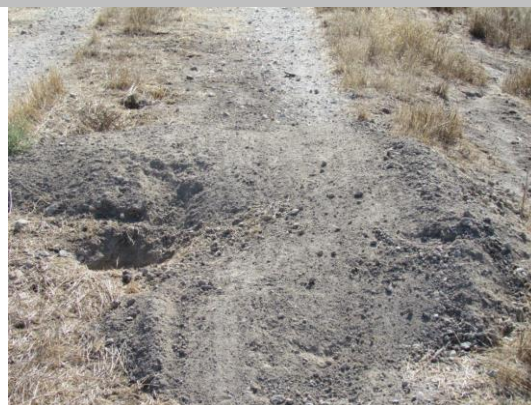
Photo 1 of 1 : SP\_2016\_NA0011\_146\_10\_20160223\_00004.jpg

LM Start	0.39	Rating **	M	Issue No.	10
LM End	0.43	Issue Type +	Ma	Location *	CR
Category	Earthen Levee			GPS Latitude/Longitude	
				Start	End
Item	Animal Control			36.976962 °	36.976635 °
				-120.361762 °	-120.361193 °
DWR ID	DWR_NA0011_05_f_2015_10				
Comment Code					
A1 : Exterminate rodents and backfill and compact or grout burrows.					
Inspector Comment					
Exterminate the rodents and back fill the holes. Bait stations are needed in this area.

Huge rodent holes in the crown road way levee mile 0.39 to 0.43.

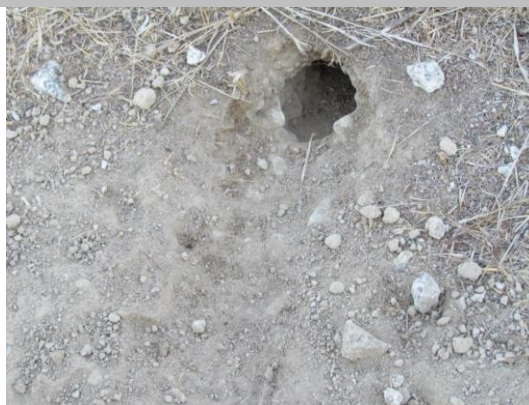
Photo 1 of 2 : SP\_2016\_NA0011\_146\_24\_20160223\_00005.jpg

LM Start	2.80	Rating **	U	Issue No.	24
LM End	3.23	Issue Type +	Ma	Location *	CR
Category	Earthen Levee			GPS Latitude/Longitude	
				Start	End
Item	Animal Control			36.968030 °	36.968082 °
				-120.323677 °	-120.315832 °
DWR ID	DWR_NA0011_05_f_2015_24				
Comment Code					
A1 : Exterminate rodents and backfill and compact or grout burrows.					
Inspector Comment					
Exterminate the rodents at this location. Bait stations are needed along this reach.

Rodent holes in the crown roadway(fresh).

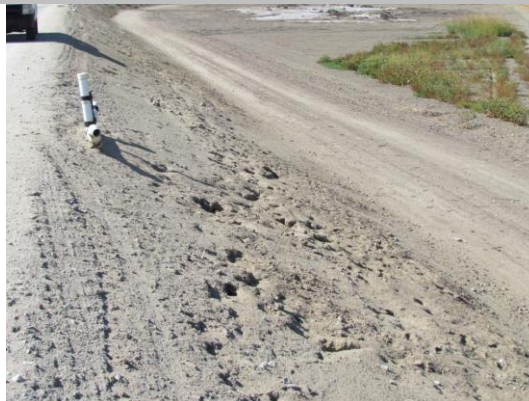
Photo 1 of 1 : SP\_2016\_NA0011\_146\_44\_20160223\_00010.jpg

LM Start	6.63	Rating **	U	Issue No.	44
LM End	6.82	Issue Type +	Ma	Location *	LS
Category	Earthen Levee			GPS Latitude/Longitude	
				Start	End
Item	Animal Control			36.968585 °	36.969465 °
				-120.254425 °	-120.251303 °
DWR ID	DWR_NA0011_05_f_2014_44				
Comment Code					
A1 : Exterminate rodents and backfill and compact or grout burrows.					
Inspector Comment					
Fresh bait is needed in the bait station, more activity at this site.

This area has an active rodent presence from levee mile 6.63 to 6.82.

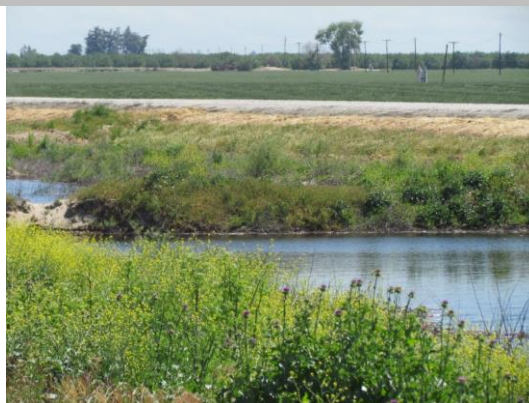
Photo 1 of 1 : SP\_2016\_NA0011\_146\_34\_20160502\_00025.jpg

LM Start	6.65	Rating **	U	Issue No.	34
LM End	6.65	Issue Type +	En	Location *	WS
Category	Rivers, Channels & Designated Floodways			GPS Latitude/Longitude	
				Start	End
Item	Encroachments			36.968625 °	36.968625 °
				-120.254185 °	-120.254185 °
DWR ID	DWR_NA0011_05_f_2015_34				
Comment Code					
Inspector Comment					
This earthen Dam was placed at this location by Chowchilla Flood Control and Public Works Department. I called the Superintendent in the past and reported this as an Unauthorized Encroachment across the Fresno River. He sent out a crew and removed the Dam, the following year they replaced it. This Dam should not be allowed across the channel during Flood season.

Looking at the earthen dam upstream of the Fresno River Flood Control Structure.

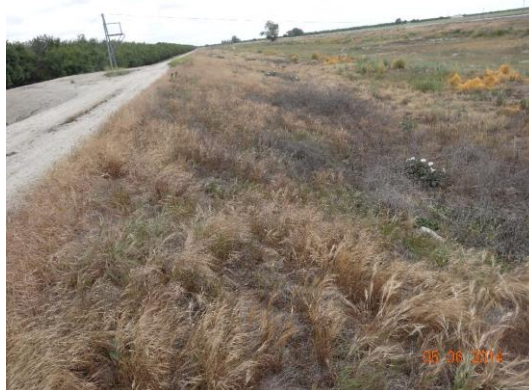
Photo 1 of 2 : UCIP\_SP\_2016\_39006\_69715.jpg

Comment Code					
Inspector Comment					
FS_ID:39006					
DS_ID:21527					
EP_NO: N/A					
Repair Type: Non-Urgent					
Crossing Status: Found					
UCIP Comments: Need to contact owner. Dense vegetation limits the inspector's visibility to identify signs of pipe failure (leaks) along the waterward slope. Recommend removing vegetation along pipe alignment to conduct proper inspection of structure and appurtenances. Slide gate buried on landward side. Recommend clearing sediment deposit on landward side.					
FIELD_STRUCT_DESC: 30-inch CM pipe through levee, 9.4 feet below the crown. Headwalls and wingwalls on both ends. Slide gate on landward end. Flap gate on waterward end.					
FS Date: 5/6/2014

View of waterward side.

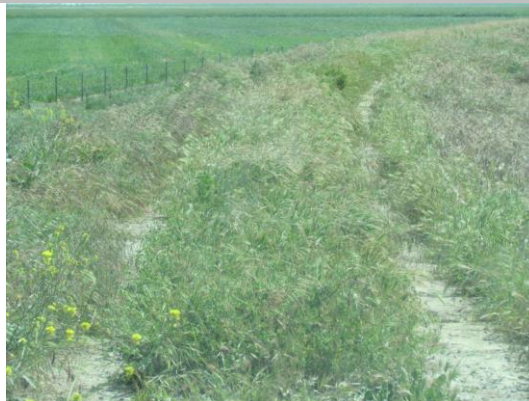
Photo 1 of 1 : SP\_2016\_NA0011\_146\_45\_20160502\_00028.jpg

LM Start	7.11	Rating **	U	Issue No.	45	
LM End	7.52	Issue Type +	Ma	Location *	CR	
Category	Earthen Levee			GPS Latitude/Longitude		
				Start		End
Item	Vegetation			36.969512 °		36.969528 °
				-120.245957 °		-120.238603 °
DWR ID	DWR_NA0011_05_f_2014_45					
Comment Code						
V9 : Keep the crown roadway free of vegetation.						
Inspector Comment						
Keep crown roadway free of vegetation, weeds here are 2.0 foot.

Looking upstream of crown roadway from levee mile 7.11- 7.52.

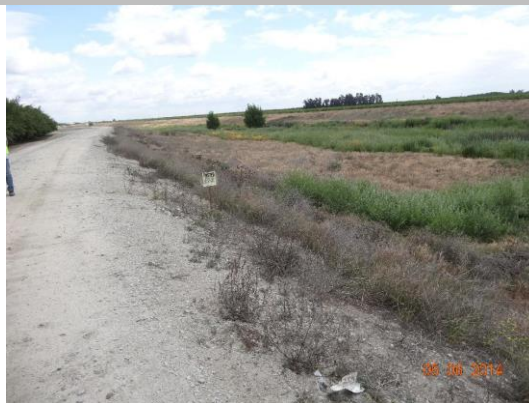
Photo 1 of 2 : UCIP\_SP\_2016\_38235\_69719.jpg

LM Start	8.09	Rating **	M	Issue No.	47
LM End	8.09	Issue Type +	En	Location *	CR
Category	Supplemental			GPS Latitude/Longitude	
				Start	End
Item	DWR UCIP Field Study			36.972415 °	36.972415 °
				-120.229285 °	-120.229285 °
DWR ID					
Comment Code					
Inspector Comment					
FS_ID:38235 DS_ID:21528 EP_NO: N/A Repair Type: Non-Urgent Crossing Status: Found UCIP Comments: Need to contact owner. Dense vegetation limits the inspector's visibility to identify signs of pipe failure (leaks) along the waterward slope. Recommend removing vegetation along pipe alignment to conduct proper inspection of structure and appurtenances. FIELD_STRUCT_DESC: 30-inch CM pipe through levee, 8.3 feet below the levee crown. Headwalls and wingwalls on both ends. Flap gate on waterward end. FS Date: 5/6/2014

View of waterward side.

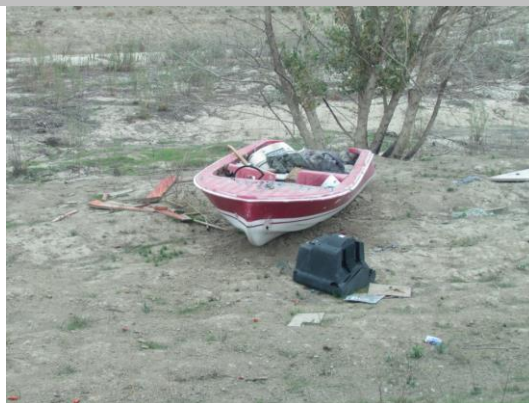
Photo 1 of 1 : SP\_2016\_NA0011\_147\_46\_20160223\_00010.jpg

LM Start	0.50	Rating **	U	Issue No.	46
LM End	0.50	Issue Type +	En	Location *	WS
Category	Earthen Levee			GPS Latitude/Longitude	
				Start	End
Item	Encroachments			36.974363 °	36.974363 °
				-120.359492 °	-120.359492 °
DWR ID	DWR_NA0011_06_f_2014_46				
Comment Code					
DE : Debris					
Inspector Comment					
Abandon boat dumped on waterside berm.

Waterside levee mile 0.51 abandoned boat. Busted tv and other trash dumped on the dry channel.

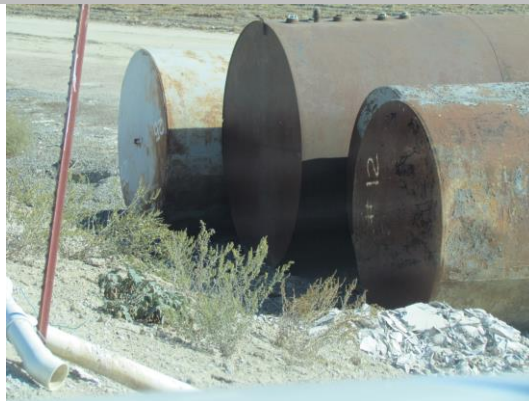
Photo 1 of 2 : SP\_2016\_NA0011\_147\_39\_20160223\_00007.jpg

LM Start	1.16	Rating **	U	Issue No.	39
LM End	1.16	Issue Type +	En	Location *	LS
Category	Earthen Levee			GPS Latitude/Longitude	
				Start	End
Item	Encroachments			36.967299 °	36.967299 °
				-120.352014 °	-120.352014 °
DWR ID	DWR_NA0011_06_s _ 2014_39				
Comment Code					
TA : Tank					
Inspector Comment					
Metal storage tanks stored within the 10-foot easement need to be removed.

Metal storage tanks within the landside easement.

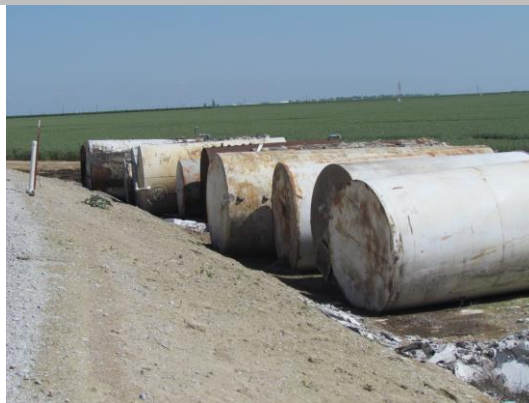
Photo 2 of 2 : SP\_2016\_NA0011\_147\_39\_20160502\_00034.jpg

LM Start	<b>1.16</b>	Rating **	U	Issue No.	<b>39 (cont)</b>
LM End	<b>1.16</b>	Issue Type +	En	Location *	LS

Metal storage tanks within the landside easement.

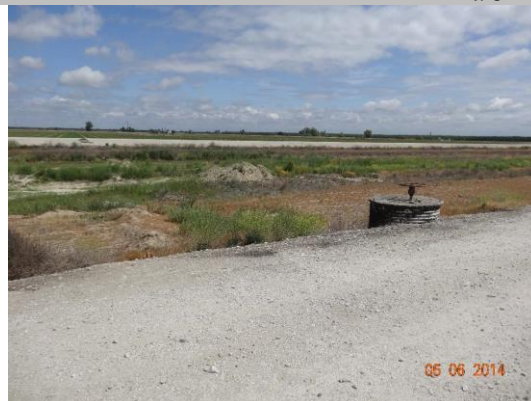
Photo 1 of 2 : UCIP\_SP\_2016\_39008\_64570.jpg

LM Start	<b>6.17</b>	Rating **	M	Issue No.	<b>53 (cont)</b>
LM End	<b>6.17</b>	Issue Type +	En	Location *	LS

View of waterward side.

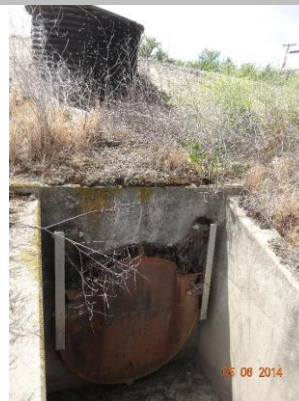
Photo 2 of 2 : UCIP\_SP\_2016\_39008\_64573.jpg

Flap gate, concrete headwall, and standpipe on waterward side.

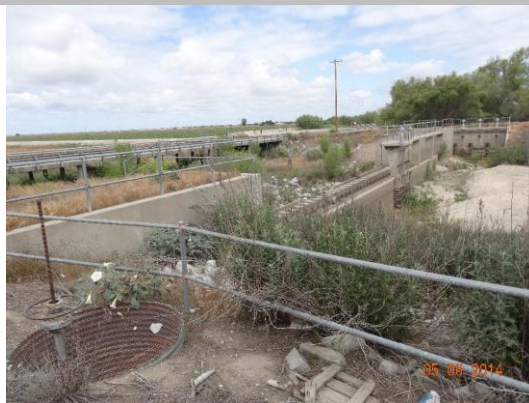
Photo 1 of 2 : UCIP\_SP\_2016\_38237\_69722.jpg

LM Start	6.51	Rating **	U	Issue No.	52
LM End	6.51	Issue Type +	En	Location *	LS
Category	Supplemental			GPS Latitude/Longitude	
				Start	End
Item	DWR UCIP Field Study			36.967941 °	36.967941 °
				-120.255467 °	-120.255467 °
DWR ID					
Comment Code					
Inspector Comment					
FS_ID:38237					
DS_ID:21532					
EP_NO: N/A					
Repair Type: Urgent					
Crossing Status: Found					
UCIP Comments: Need to contact owner. Crossing on landward side appears to be modified--no headwall found on landward end.					
FIELD_STRUCT_DESC: 30-inch CM pipe through levee 12 feet below crown. Slide gate in 5-foot CM pipe riser on waterward shoulder.					
Headwalls and wingwalls on waterward end. Headwall on landward end.					
FS Date: 5/6/2014

View of waterward side.

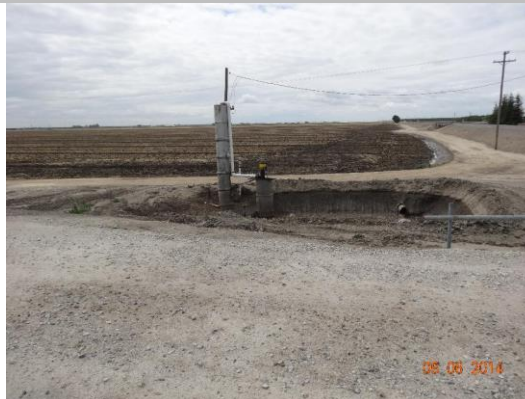
Photo 2 of 2 : UCIP\_SP\_2016\_38237\_69724.jpg

LM Start	6.51	Rating **	U	Issue No.	52 (cont)
LM End	6.51	Issue Type +	En	Location *	LS
Category	Supplemental			GPS Latitude/Longitude	
				Start	End
Item	DWR UCIP Field Study			36.967941 °	36.967941 °
				-120.255467 °	-120.255467 °
DWR ID					
Comment Code					
Inspector Comment					
FS_ID:38237					
DS_ID:21532					
EP_NO: N/A					
Repair Type: Urgent					
Crossing Status: Found					
UCIP Comments: Need to contact owner. Crossing on landward side appears to be modified--no headwall found on landward end.					
FIELD_STRUCT_DESC: 30-inch CM pipe through levee 12 feet below crown. Slide gate in 5-foot CM pipe riser on waterward shoulder.					
Headwalls and wingwalls on waterward end. Headwall on landward end.					
FS Date: 5/6/2014

View of landward side.

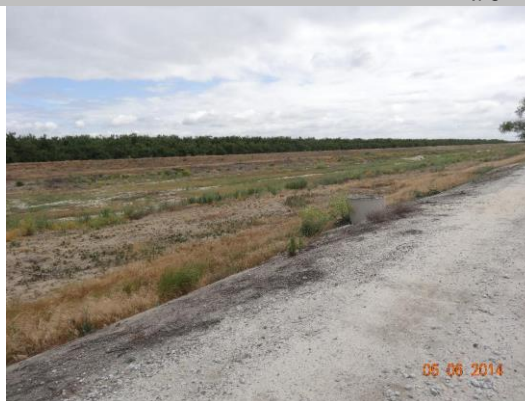
Photo 1 of 2 : UCIP\_SP\_2016\_35804\_64585.jpg

Comment Code					
Inspector Comment					
FS_ID:35804 DS_ID:21587 EP_NO: 13837 Repair Type: Non-Urgent Crossing Status: Found UCIP Comments: Need to contact owner. Dense vegetation limits the inspector's visibility to identify signs of pipe failure (leaks) along the waterward slope. Recommend removing vegetation along pipe alignment to conduct proper inspection of structure and appurtenances. FIELD_STRUCT_DESC: 12 inch diameter reinforced concrete pipe through levee at 7.5 feet below flood plane. The pipe line extends to a 27 inch concrete standpipe, located within the overflow area, through the levee section to a 30 inch diameter standpipe located on landward side. Positive closure device located on the waterward side. Walkway extends to positive closure device. (Permit No. 13837, Averill Ranch-1984) FS Date: 5/6/2014

View of waterward side.

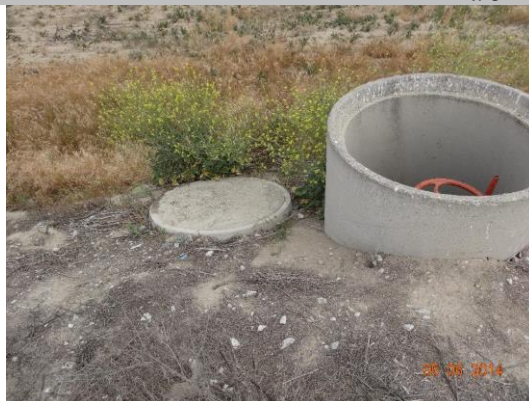
Photo 2 of 2 : UCIP\_SP\_2016\_35804\_64588.jpg

Comment Code						
Inspector Comment						
FS_ID:35804 DS_ID:21587 EP_NO: 13837 Repair Type: Non-Urgent Crossing Status: Found UCIP Comments: Need to contact owner. Dense vegetation limits the inspector's visibility to identify signs of pipe failure (leaks) along the waterward slope. Recommend removing vegetation along pipe alignment to conduct proper inspection of structure and appurtenances. FIELD_STRUCT_DESC: 12 inch diameter reinforced concrete pipe through levee at 7.5 feet below flood plane. The pipe line extends to a 27 inch concrete standpipe, located within the overflow area, through the levee section to a 30 inch diameter standpipe located on landward side. Positive closure device located on the waterward side. Walkway extends to positive closure device. (Permit No. 13837, Averill Ranch-1984) FS Date: 5/6/2014

View of concrete standpipe and lid found on waterward shoulder.

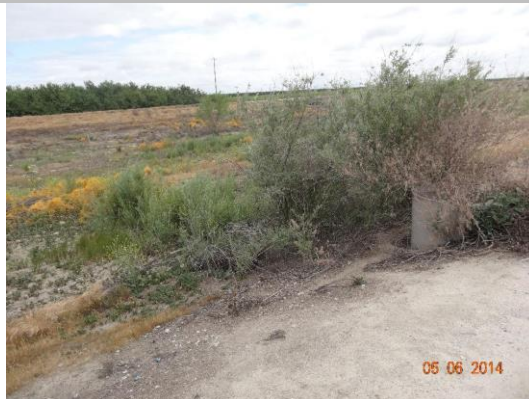
Photo 1 of 2 : UCIP\_SP\_2016\_35805\_64590.jpg

LM Start	<b>7.42</b>	Rating **	M	Issue No.	<b>49 (cont)</b>
LM End	<b>7.42</b>	Issue Type +	En	Location *	LS

View of waterward side.

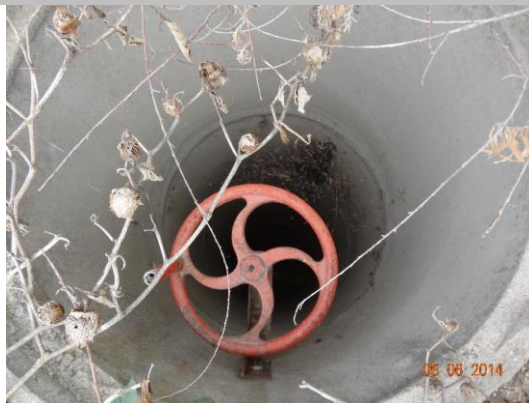
Photo 2 of 2 : UCIP\_SP\_2016\_35805\_64589.jpg

FS\_ID:35805  
DS\_ID:21588  
EP\_NO: 13856  
Repair Type: Non-Urgent  
Crossing Status: Found  
UCIP Comments: Need to contact owner. Dense vegetation limits the inspector's visibility to identify signs of pipe failure (leaks) along the waterward slope. Recommend removing vegetation along pipe alignment to conduct proper inspection of structure and appurtenances.  
FIELD\_STRUCT\_DESC: 12 inch diameter gravity reinforced concrete irrigation pipe through levee approximately 4 feet below crown. The pipeline extend from a 24 inch diameter standpipe, located within the overflow area, through the levee section to a 36 inch diameter standpipe located on landward side. Positive closure device located on waterward side of the levee with an accessible walkway. (Permit No. 13856, Averill Ranch-1984)  
FS Date: 5/6/2014

Inside view of standpipe located on waterward side.

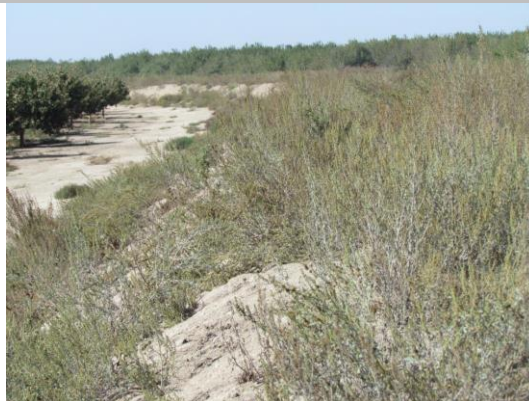
Photo 1 of 1 : SP\_2016\_NA0011\_147\_27\_20160223\_00004.jpg

LM Start	7.63	Rating **	U	Issue No.	27
LM End	8.52	Issue Type +	Ma	Location *	LS
Category	Earthen Levee			GPS Latitude/Longitude	
				Start	End
Item	Vegetation			36.969052 °	36.971510 °
				-120.235442 °	-120.220425 °
DWR ID	DWR_NA0011_06_f_2015_27				
Comment Code					
V1 : Control annual grass and weeds on the levee slopes and easements.					
Inspector Comment					
Remove the tumble weed and other unwanted tall weeds form the landside levee section.

Fresno River Looking at the landside levee slope unsatisfactory tall weeds has covered the slope, shoulder and crown.

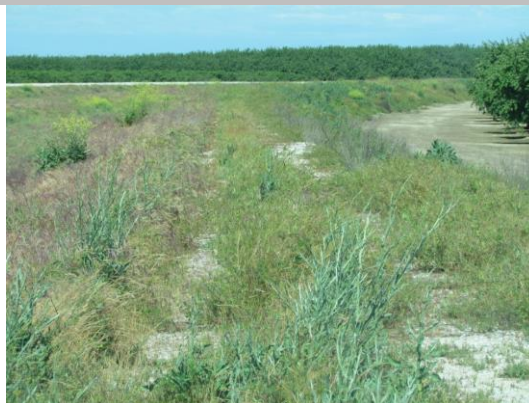
Photo 1 of 1 : SP\_2016\_NA0011\_147\_22\_20160502\_00036.jpg

LM Start	7.70	Rating **	U	Issue No.	22
LM End	8.53	Issue Type +	Ma	Location *	CR
Category	Earthen Levee			GPS Latitude/Longitude	
				Start	End
Item	Vegetation			36.969557 °	36.971487 °
				-120.234278 °	-120.220345 °
DWR ID	DWR_NA0011_06_s_2016_22				
Comment Code					
V1 : Control annual grass and weeds on the levee slopes and easements.					
Inspector Comment					
Control the wild weeds from the crown roadway.

Looking upstream from levee mile 7.70-8.53, tall weeds 3.0-4.0 foot tall on the crown.

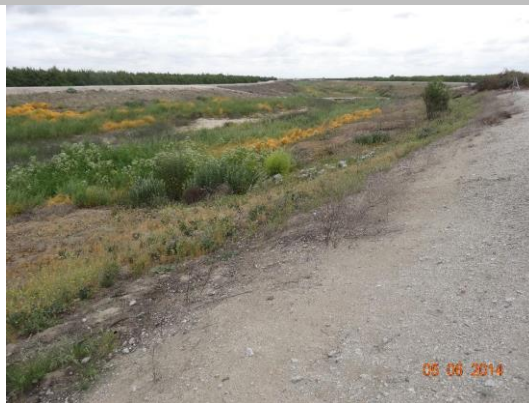
Photo 1 of 2 : UCIP\_SP\_2016\_35806\_64596.jpg

LM Start	8.53	Rating **	M	Issue No.	50
LM End	8.53	Issue Type +	En	Location *	WS
Category	Supplemental			GPS Latitude/Longitude	
				Start	End
Item	DWR UCIP Field Study			36.971462 °	36.971462 °
				-120.220276 °	-120.220276 °
DWR ID					
Comment Code					
Inspector Comment					
FS_ID:35806 DS_ID:21534 EP_NO: N/A Repair Type: Non-Urgent Crossing Status: Found UCIP Comments: Need to contact owner. Rip rap has been added around concrete headwall on waterward side--need to determine details for rip rap around structure. FIELD_STRUCT_DESC: 30-inch CM pipe through levee, 11.0 feet below crown. Headwalls and wingwalls on both ends. Flap gate on waterward end. FS Date: 5/6/2014

View of waterward side.

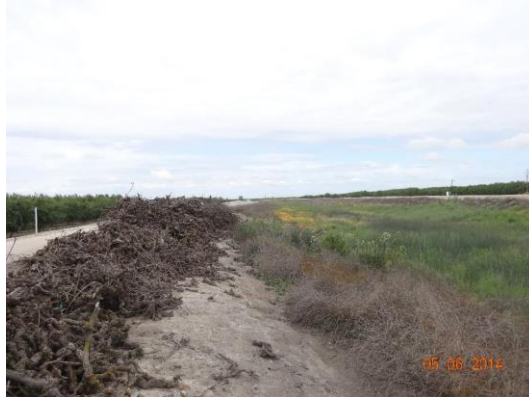
Photo 1 of 2 : UCIP\_SP\_2016\_42857\_64605.jpg

LM Start	8.94	Rating **	U	Issue No.	54
LM End	8.94	Issue Type +	En	Location *	WS
Category	Supplemental			GPS Latitude/Longitude	
				Start	End
Item	DWR UCIP Field Study			36.972307 °	36.972307 °
				-120.213185 °	-120.213185 °
DWR ID					
Comment Code					
Inspector Comment					
FS_ID:42857 DS_ID:21530 EP_NO: N/A Repair Type: Urgent Crossing Status: Found UCIP Comments: Need to contact owner. Surface erosion on landward slope unable to determine if pipe failed or if rodent activity burrow hole has caused collapse on slope. Need to determine cause for erosion. FIELD_STRUCT_DESC: 30-inch CM pipe through levee, 10.2 feet below crown. Headwalls and wingwalls on both ends. Flap gate on waterward end. FS Date: 5/6/2014

View of waterward side.

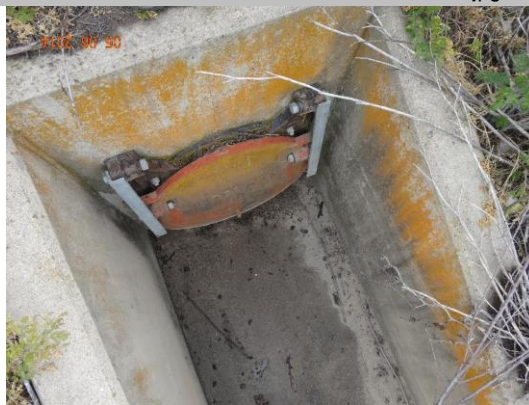
Photo 2 of 2 : UCIP\_SP\_2016\_42857\_64604.jpg

LM Start	<b>8.94</b>	Rating **	U	Issue No.	<b>54 (cont)</b>
LM End	<b>8.94</b>	Issue Type +	En	Location *	WS

Flap gate visible on waterward side.
